## ELECON REVS

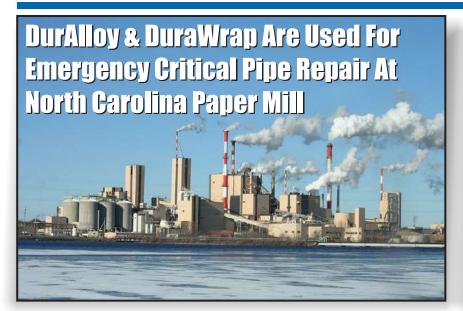
This paper mill in North Carolina was being restarted after a two-week maintenance shutdown. One critical process pump moving acid wash water was being put back into service, and the water pressure and flow volume created a "water hammer" against the inner walls of the pipe's elbow section. This caused the elbow to become the "fail point" of the pipe, resulting in a massive leak.

The local ENECON Distributor for North and South Carolina was contacted to provide an emergency solution to this problem. The edges of the hole and the edges of the pipe section that came out of the elbow were cleaned using electric grinders.

The broken pipe section piece was replaced in its original position using *DurAlloy*. The total area of the pipe elbow was then cleaned using grinders with sanding discs.

A four-layer METALCLAD DuraWrap carbon fiber pipe wrap system was used to make this repair. Proper cure times were allowed, and the pump was put back into service.
