CHEMCLAD

Repairs

This Scrubber For Peanuts!

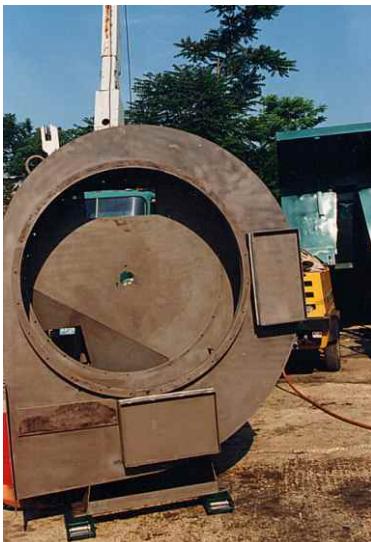
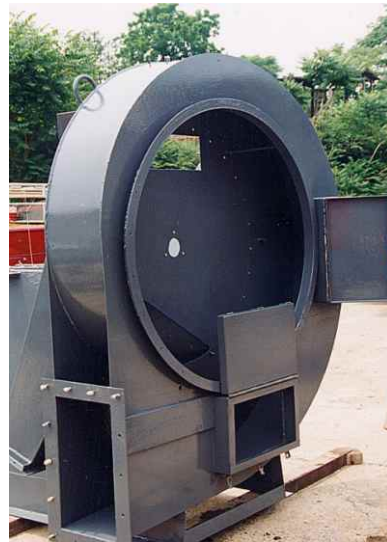
This ROTO-CLONE scrubber on a peanut roaster for a major candy manufacturer had been suffering from progressive corrosion - on both the inside and the outside of the unit - during its several years in service.

Upon completion of the preparation phase, a number of areas were found to be corroded completely through the casing. These severely damaged areas were

It was determined that the best way to carry out the project was to remove the entire unit from its roof-top mounting and lower it to ground level for transport to an off-site facility for disassembly, repair and coating. Once there, the entire unit was dismantled and, after extensive cleaning operations, all components to be coated were thoroughly grit blasted.

quickly and easily repaired with METALCLAD SpeedAlloy prior to the application of the CHEMCLAD SC.

Two coats of the CHEMCLAD SC were applied to all internal and external surfaces to restore the equipment and prevent further corrosion. The entire project, including dynamic balancing of the rotating components and reinstallation on the roof, was completed in about one week - well within the schedule allotted for the project.
