Spanish Nuclear Plant Repairs and Protects Secondary Containment Areas with DuraQuartz and CHEMCLAD

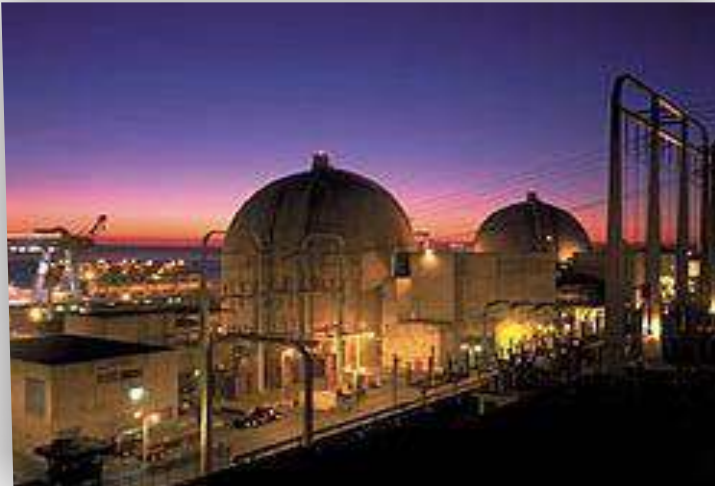
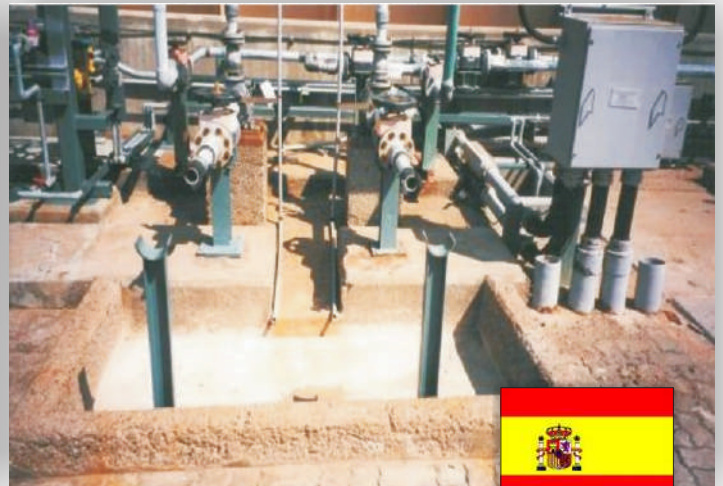
These secondary containment areas and pump supports at a Spanish nuclear power station had been attacked by strong acids

and alkalis for many years, causing severe deterioration and crumbling of the concrete.

It was recommended that the damaged concrete surfaces first be repaired and rebuilt with **ENECRETE DuraQuartz**. This would be followed by a two-coat application of **CHEMCLAD GP** (gray+tan) to provide long-term protection to the containment areas.
