*New Jersey Grout
Manufacturer
Repairs & Protects
Containment Areas
with DuraQuartz,
FPS &
CHEMCLAD GP.*

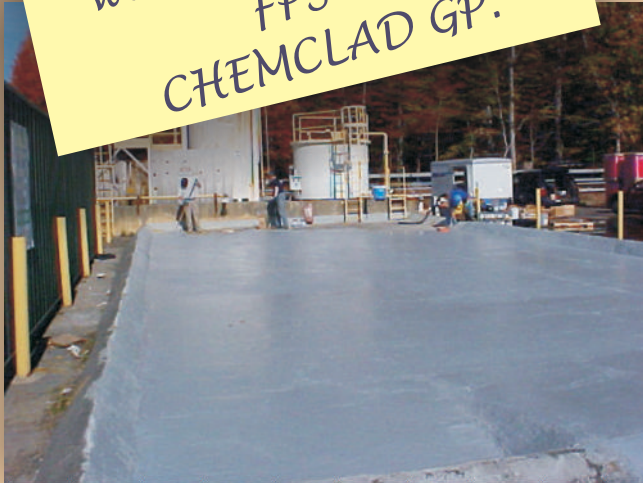
This, the largest of the three areas was first power washed, then abraded with a floor sander; cracks were repaired with ENECRETE DuraQuartz and then coated with ENECLAD FPS.

This \$31,000 project included three containment areas. The largest was asphalt and the other two were concrete. The asphalt had been previously coated with an epoxy paint which had deteriorated and

cracked. The concrete areas had never been coated.

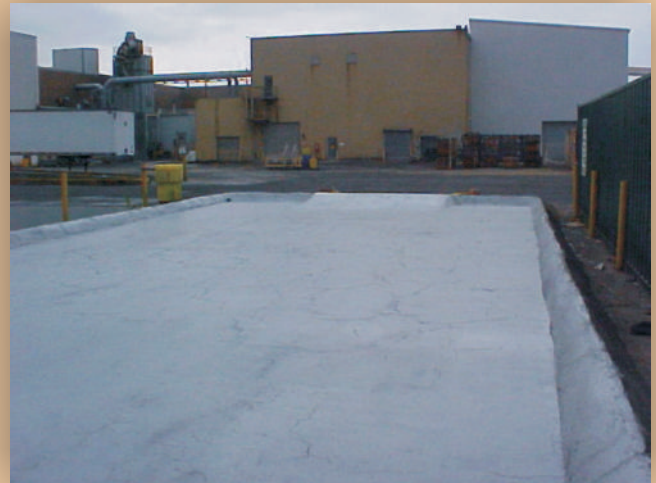
View from the opposite direction. Pallets containing drums of chemicals are stored here.

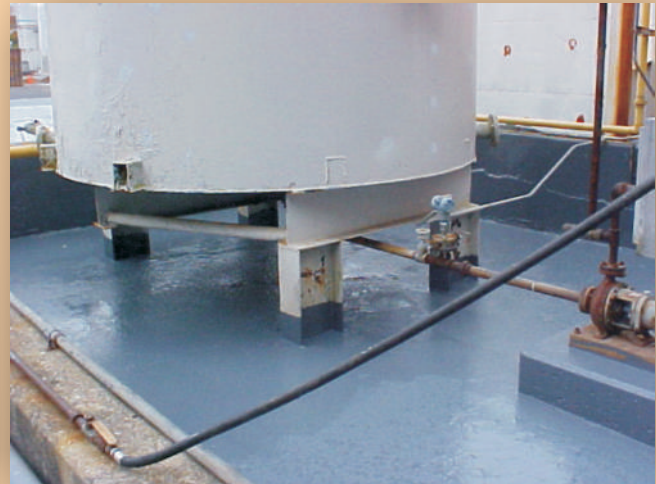
The third containment area was repaired and protected as per the second containment area.
