Russian Fertilizer Plant Solves Floor Problems with ENECLAD and CHEMCLAD

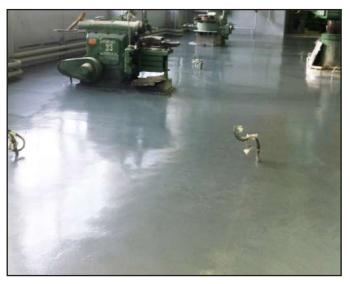
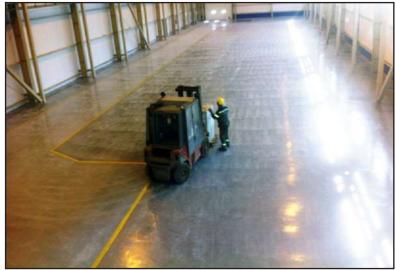
One of the largest chemical companies in Russia – a leader in the production of nitrogen fertilizers – had a number of problem floor issues totaling 90,000 sq. ft.

They wanted a longterm repair and protection solution and they also wanted a professional organization to provide a complete turnkey solution. They selected ENECON Russia to provide both. After sanding/grinding and cleaning the floors, all cracks were repaired with ENECLAD CFS with locally sourced quartz sand added in. Once cured, the cracks were sanded and all dust was removed.

All driveway areas were coated with two coats of CHEMCLAD GP with non-skid aggregates broadcast and backrolled into the first coat.

The remaining floor areas were treated with

two coats of ENECLAD CFS – the first coat was tinted with a gray pigment and the second coat was left clear.

Yellow markings were done with DuraFill and yellow colored sand. Once cured, excess sand was removed and a top coat of ENECLAD CFS was then applied to seal the striping.
