Bridge Repaired With ENECRETE, CHEMCLAD, METALCLAD & ENESEAL

ENECON® NEWS

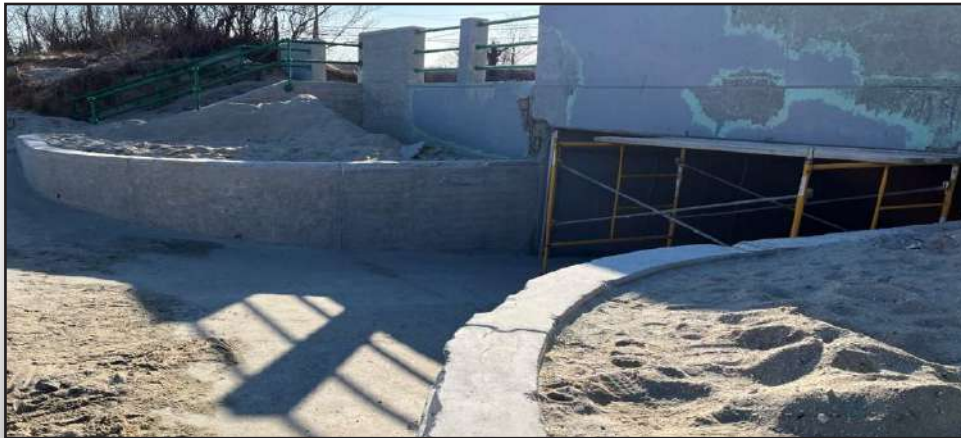
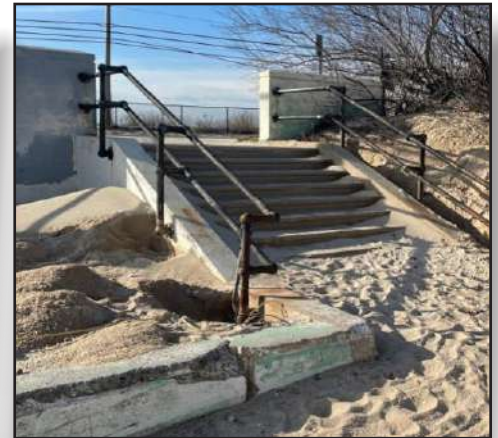
This small island's bridge, beach access staircase and tunnel were deteriorating due to their proximity and decades of exposure to saltwater spray. Not only was this an eyesore, but residents were equally concerned with their safety and the safety of the community.

ENECON's exclusive distributor in the northeastern U.S. first repaired all the damaged and missing concrete using fiber-reinforced polymer rebar (FRP) and *ENECRETE DuraFill*. The stairs were reformed using *ENECRETE DuraQuartz* and

The steel supports under the bridge were grit blasted and formed with *ENECRETE DuraQuartz*. The support's steel was then reinforced using a *METALCLAD DuraWrap Carbon Fiber* system.

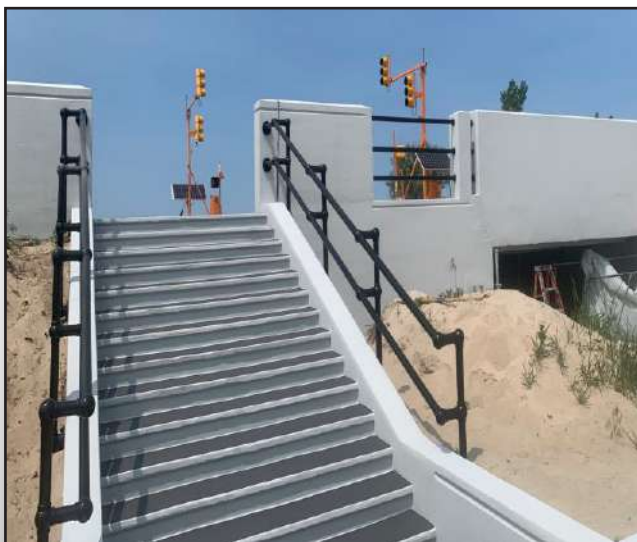
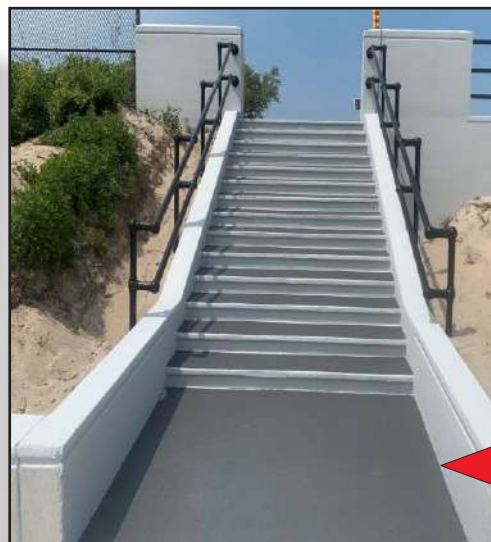
**Final
CHEMCLAD GP
topcoat with
aggregate
broadcast
for ultimate
slip-resistance
properties**

CHEMCLAD GP with an aggregate broadcast to create a slip-resistant surface.
