## Sweep Arm's "Smooth Ride" Courtesy of ENECRETE DuraQuartz

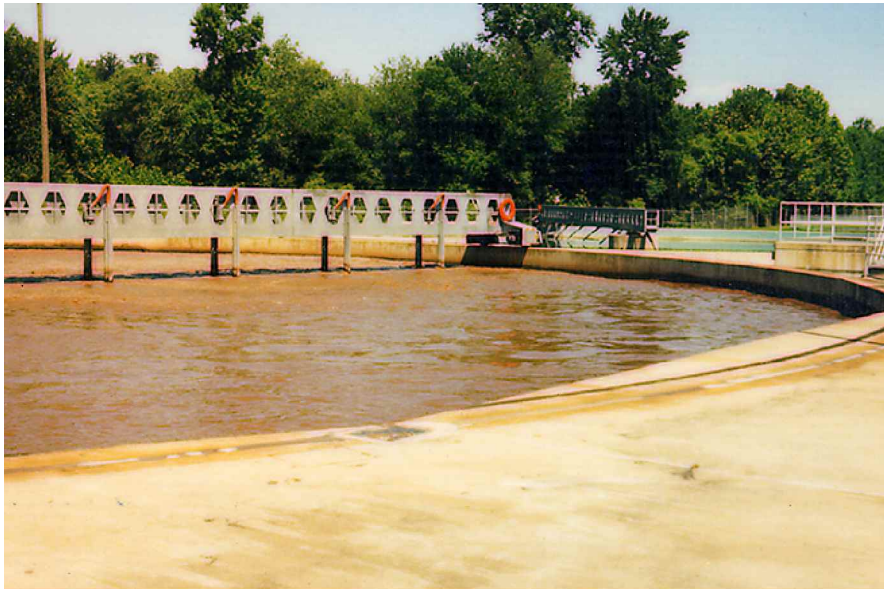
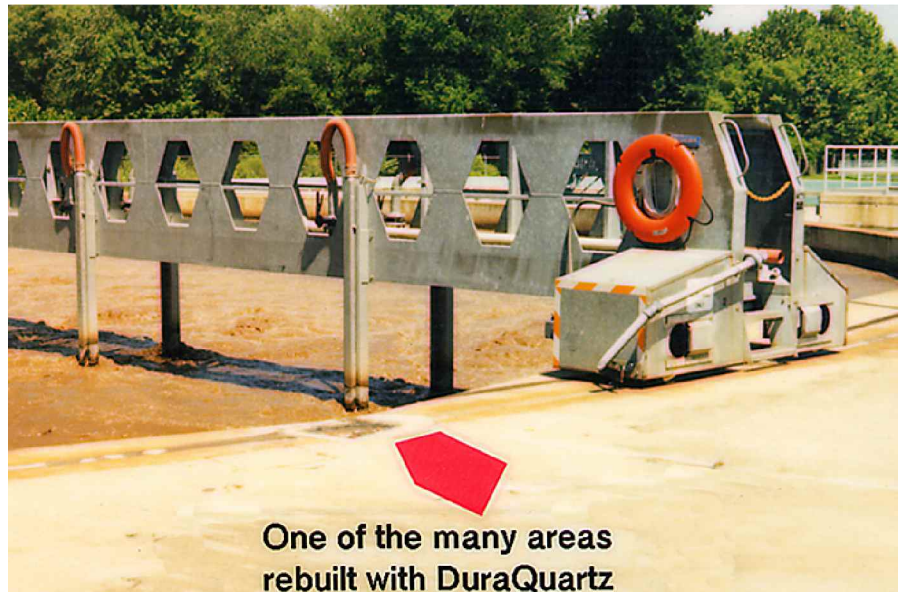
The top of the concrete wall of this 140 foot diameter aeration basin at a **Waste Water Treatment Plant** had numerous cracks and spalled areas. These irregularities in the track area caused the wheels of the "sweep arm" to bounce, further damaging the concrete and stressing the equipment.

The engineers tried numerous repair materials in trying to solve the problem. However, nothing they found could stand up to the 7 ton load carried by the two track wheels as they rotated the basin every two minutes.

The local ENECON Fluid Flow Systems Specialist in Virginia, suggested the use of the ENECRETE DuraQuartz to solve the problem. Impressed with the outstanding properties of the DuraQuartz, the plant's Maintenance Supervisor agreed to give it a try.

The Supervisor reported that, **not only is the DuraQuartz "doing the job", but the smoother riding wheels would extend the life of the sweep arm as well as allow for better air circulation into the aeration basin.**
