## ENECLAD FPS Revitalizes Main Entrance For This Pennsylvania Manufacturer

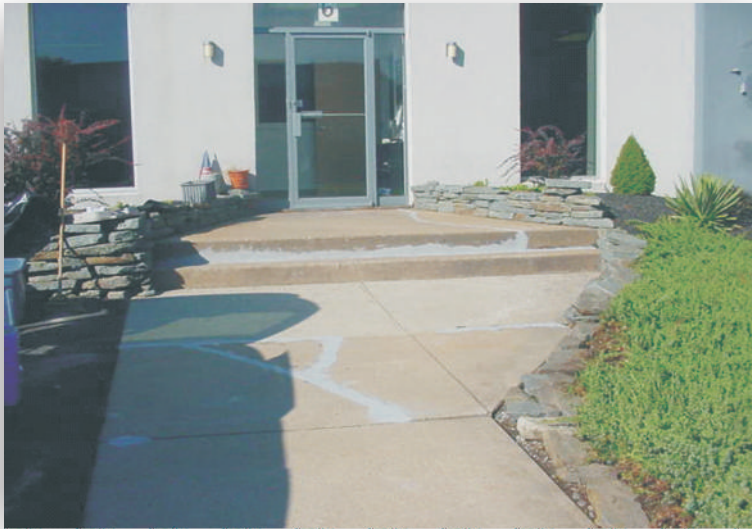
The main entrance for this manufacturing company was showing its age. The concrete was cracked and deteriorated. The conventional approach would have required removing the old concrete and pouring new steps and walkway. The corresponding downtime would have presented problems since this entrance was the main access to the facility.

The concrete was first power washed and allowed to dry. DuraQuartz was used to repair all the cracks and heavily damaged areas. ENECRETE Self Priming Screed (SPS) was then applied to smooth out the rough

concrete surface. Finally, two coats of ENECLAD FPS were installed by roller and a #46 aluminum oxide aggregate was 'back-rolled' into the topcoat to provide for a safety, non-slip surface. This project was accomplished in just two days to the complete satisfaction of the building owners.
